Erik Hestnes*, Steinar Bakkehøi and Christian Jaedicke
Norwegian Geotechnical Institute (NGI), Oslo, Norway

ABSTRACT: Longyearbyen, the administrative centre of the Svalbard archipelago, is facing most types of natural hazards under a changing Arctic climate. The catastrophic avalanche in December 2015 led NGI to review our professional work during 30 years of research and consulting in the community. Hazard zonation in Longyearbyen has been a tool in area planning, not for hazard assessment of developed areas, and mainly done during the early 1990s based on current knowledge and methods. The procedures for avalanche warning in Longyearbyen reflects that avalanche release is primarily a consequence of drifting snow, embedded surface snow and collapse of cornices. The first indication in meteorological data of a change in climate was a heavy rainfall midwinter 1995/96, years before global warming of the Arctic was documented. Field research in the 1990s documented that runout in terms of α -angle is longer in cold regions than in other areas. NGI has advised the local administration to revise the old hazard zones taking changing climate and up-dated knowledge and methods into accou

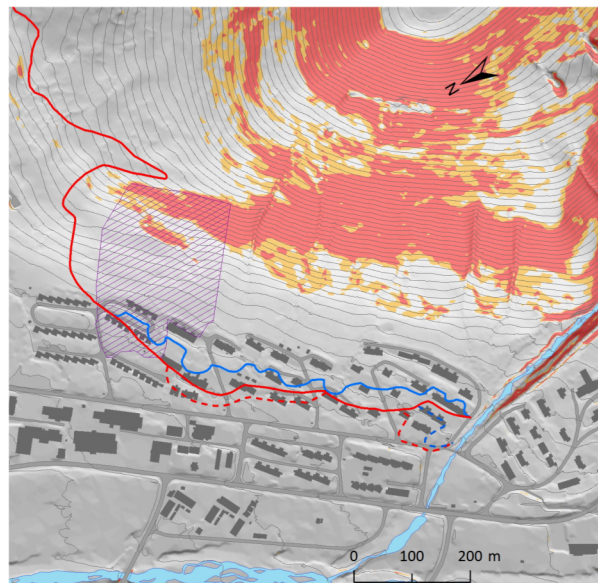
Fig. 2: Lia and Vannledningsdalen (right). The hazard zones of avalanches (red) and debris flows (red dotted). The disastrous avalanche 19 December 2015 (violet).

The catastrophic avalanche in 2015 stopped 25-60 m beyond the hazard zone based on the experience and runout models available in 1992. The registered runout coincides well with back-calculations based on today's knowledge and models (Fig. 2). The α -angle was approximately 16°, not a surprising value in Arctic environments.

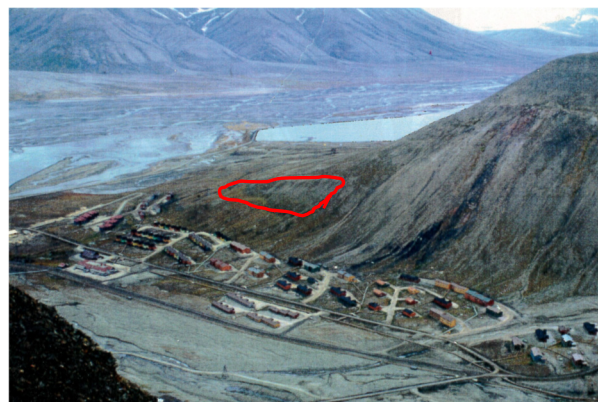
Fig. 3: Lia. The SE wind is coming from the valley in the background and is mainly depositing snow in the low hillside above the houses to the left. Photo E. Hestnes

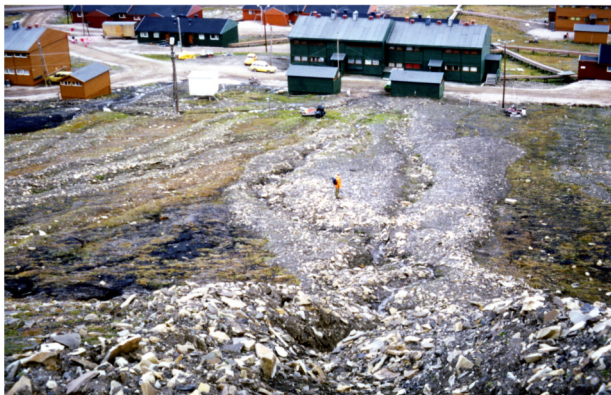
and Lied 1991, Hestnes and Bakkehøi 2003, Vogel et al. 2012). The size and frequency of debris flows depend on the weather conditions, the depth and texture of the *active layer* and the soil-water content at the time of release (Fig. 4).

Fig.4 Houses in road 226 are built on old debris and debris deposited in 1972, and hit by a debris flow in 1981. Photo E. Hestnes.

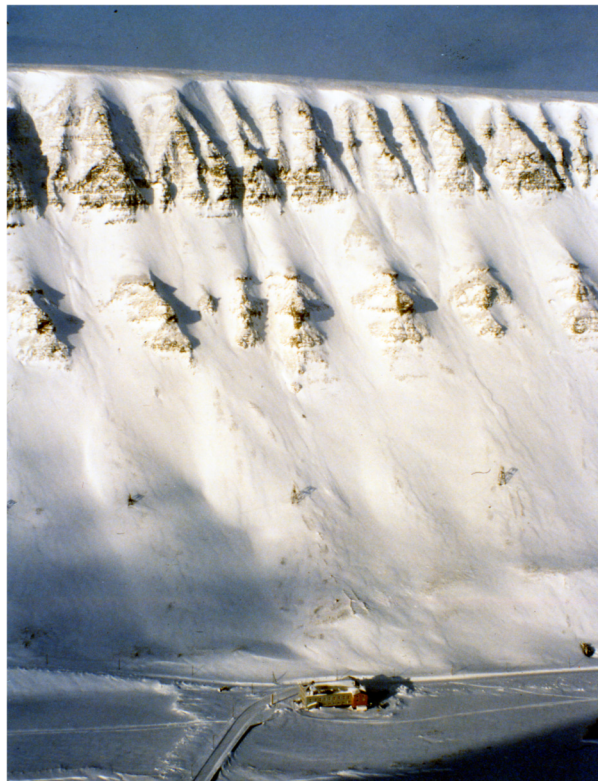
Rockfall from the steep cliffs is frequent. So far, it presents a problem primarily to cableways and constructions by the adits below the cliffs on both sides of the valley, the community centre and restaurant, as well as the road on the western side (Fig. 5). If the permafrost horizon shrinks as predicted, *rockslides* from these cliffs might become a critical hazard in the future.

Fig. 5 The community centre and restaurant Huset is exposed to avalanches and rockfall. Cornices are built along the rim. Rockslides might be a future problem. Photo E. Hestnes.

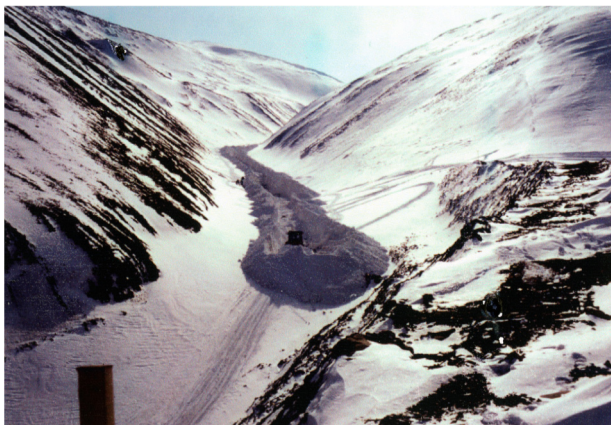
Fig. 6 Opening of the drainage channel in Vannledningsdalen by bulldozer before periods of run-off. Photo E. Hestnes

has been missing, except for the contribution by SNSK to the safety of the Haugen area against slushflows (Fig. 6). Finally, at the end of 2013, the Norwegian government decided to incorporate Svalbard in the national all-around settlement of financial support for hazard evaluation and safety measures.

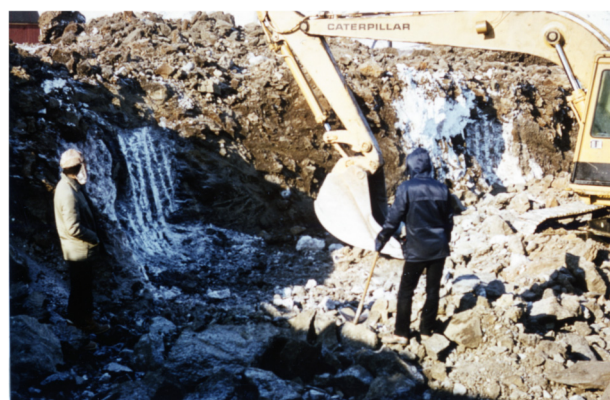
Detailed mapping of periglacial processes documented consequences to buildings and infrastructure, and ice wedges and large lenses were found to constitute a critical foundation problem (Fig. 7). Gelifluction and creep within the housing area have been monitored by inclinometers, and thermistor strings to a depth of 75-100 m in Longyearbyen and Svea have recorded changes in temperature (Lied and Hestnes 1986, Bakkehøi 2005). Problems related to periglacial processes will accelerate as the depth of the active layer increases.

Fig. 7 Great ice-wedges in a foundation cavity on road 232. Normally traceable by ground inspection. Photo O. Gregersen

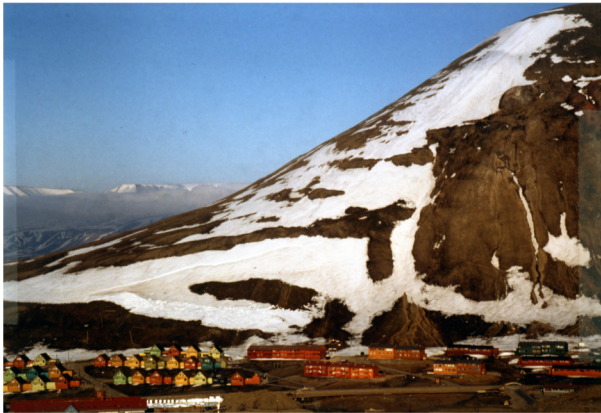
The significance of drifting snow and wind speed to avalanche hazard in Arctic environment was documented early on as unexpected avalanches occurred four times within three years in Lia, Longyearbyen (Tbl. 1). One of these avalanches stopped close to one of the houses that were destroyed by the catastrophic avalanche of 19 December 2015 (Fig. 8). NGI's research also indicates that approximately 10% of naturally released avalanches in Svalbard may have an α -angle of 20° or less. The smallest registered runout angle (the angle between crown surface and toe of deposit) was 15° (Hestnes et al. 1999). This corresponds well to documentations of runout on level ground in the mountains of the mainland. Neither precipitation intensity nor the Norwegian α/β -model based on registered extreme avalanches in the fiordland and valleys of western Norway are valid for avalanche evaluation in Arctic environments.

Fig. 8 Avalanches do occur almost every year in this part of Lia. This one was released 5 April 1991. Photo E. Hestnes (12 June 1991).

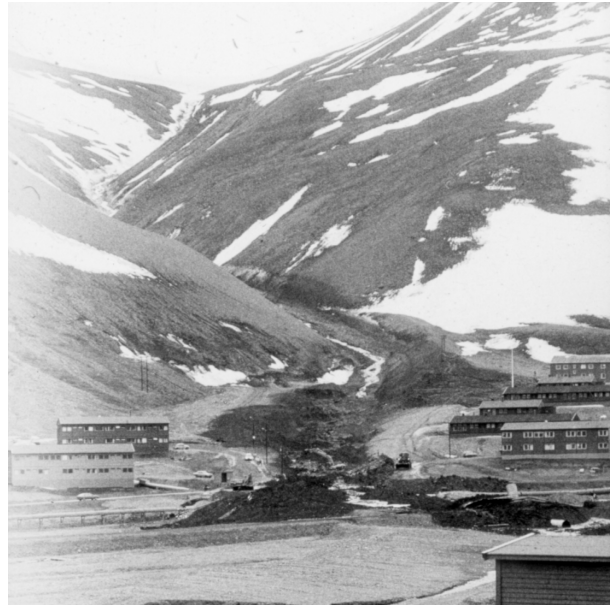
Fig. 9a The small slushflow 14 June 1989 climbed the old guiding dam and damaged a private home. It went on to the floodplain breaking the water and heating pipes and closing three roads. Photo K. Anthonsen

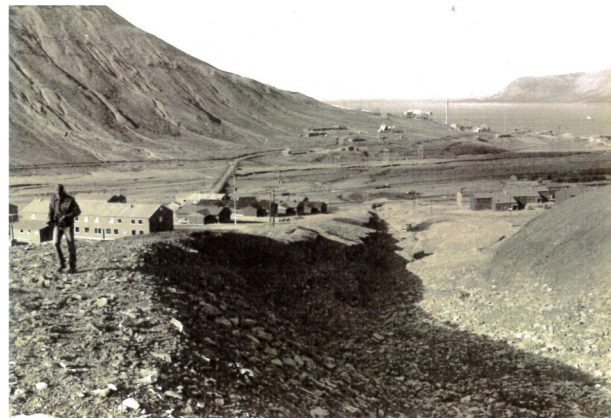
Fig. 9b The guiding dam in August 1987. The channel filled with debris and water has undercut the side. The channel and dam is maybe not maintained since construction in 1953. Photo K. Lied

Mitigative measures against slushflows from Vannledningsdalen have been a recurrent question, especially in land-use planning. In 1990, NGI recommended guiding dams in the runout zone and stabilizing the snowpack in the flat basin up-valley by strong wire-nets. Due to lack of financial resources, the community had to carry on opening the drainage channel by bulldozer before the melting season in May (Fig. 6). A review of the established routines in 1994 showed no failure vis-à-vis meteorological data over the last 38 years, but human negligence had resulted in slushflows in 1960 and 1989. NGI recommended an important supplement to those routines, expressing: *If the weather forecasts indicate potential hazard earlier in the winter season, opening of the channel will be carried out.* Already the following year, a critical rain-on-snow event occurred in December, and such events have occurred many winters after the turn of the century. The most recent destructive slushflow occurred on 30 January 2012 (Hestnes and Bakkehøi 2012). Since then, the local community has planned permanent safety measures as advised by NGI in 1990. The construction plans are now completed, but financial support is still missing.

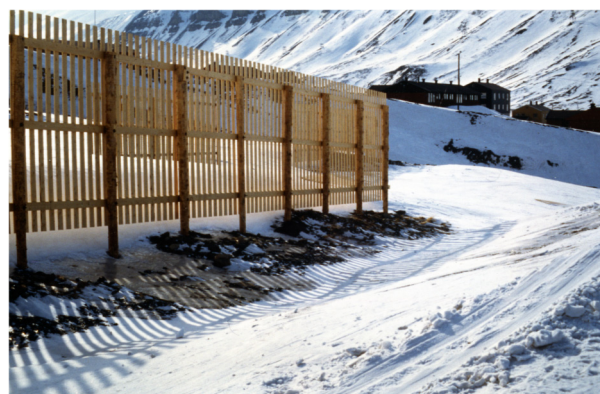
Snow fences were considered in 1990-1992 for reducing cornice formation and accumulation of snow in the most critical starting zones. In the same period, plans for using fences and redesign of roads to reduce problems with snowdrifts in doorways, on service road and roads were drawn. The plans that have been implemented have proved successful. The established fences are with vertical boards to prevent children from using them as climbing frames. However, the builder did not take the indicated wind loads into consideration, so the constructions had to be strengthened after partial failure (Fig.11).

Fig.11 Snow fence before strengthening the construction and adjusting the ground clearance. Photo E. Hestnes

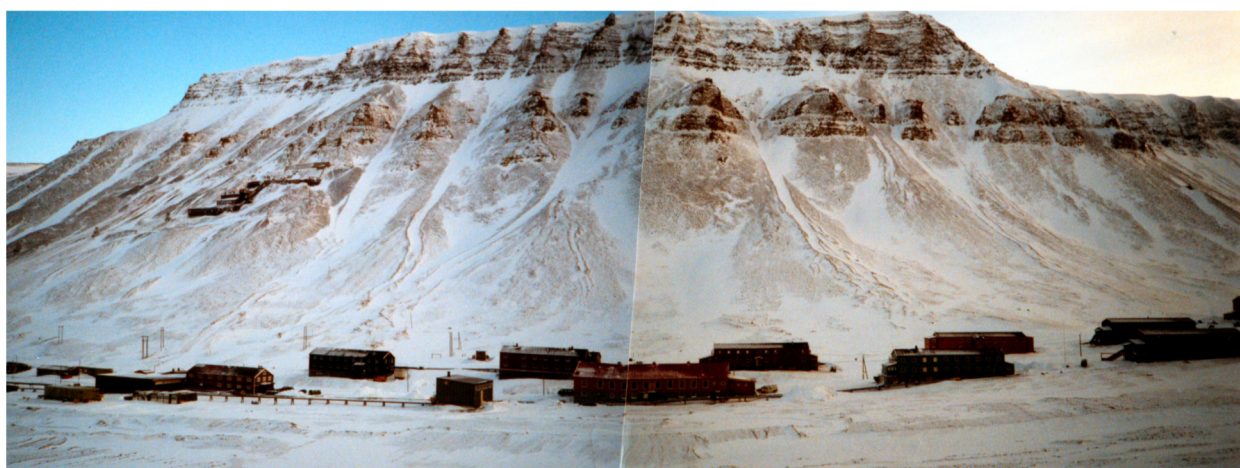
Safety measures against avalanches and debris flows have been on the agenda since 1990. A few plans are completed, others set apart. Routines for controlled release of cornices from the rim above Nybyen, as SNSK had done when the mine below was in operation, was promptly dismissed as unfit for use (Fig. 10, Hestnes and Lied 1991). The catastrophic event in December 2015 has renewed the

Fig.10 Nybyen 27 February 2003. Mid-winter and very little snow. Only small cornices along the rim above. The starting zones and paths for avalanches and debris flows below the rim are easily observed. Rockslides might be a future problem. All houses are within the hazard zone. Photo E. Hestnes
